FATIGUE ASSESSMENT OF FULL-SCALE RETROFITTED ORTHOTROPIC BRIDGE DECKS

Abstract: Full-scale fatigue tests were performed on two retrofitted orthotropic bridge decks (OBD). The retrofitting systems consist of adding a second steel plate on the top of the existing deck. The aim is to reduce the stresses at the fatigue sensitive details and therefore extend the fatigue life of the OBD by stiffening the existing deck plate. Two retrofitting systems have been studied. The bonded system consists in bonding a second steel plate to the existing deck by vacuum infusing a thin adhesive layer (2 mm) between the two steel plates. The sandwich system consists in bonding the second steel plate through a thick polyurethane core (15 mm). The aim of the study was to assess the fatigue performance of both retrofitting. No fatigue damage was detected in the retrofitting layers during fatigue tests after 3 million cycles of wheel load. The stresses close to the deck-plate-to-stiffener welds reduce by at least 55% when using the bonded steel plates system and 45% when using the sandwich steel plates system. Both systems proved to have sufficient fatigue life to withstand traffic wheel loads running on

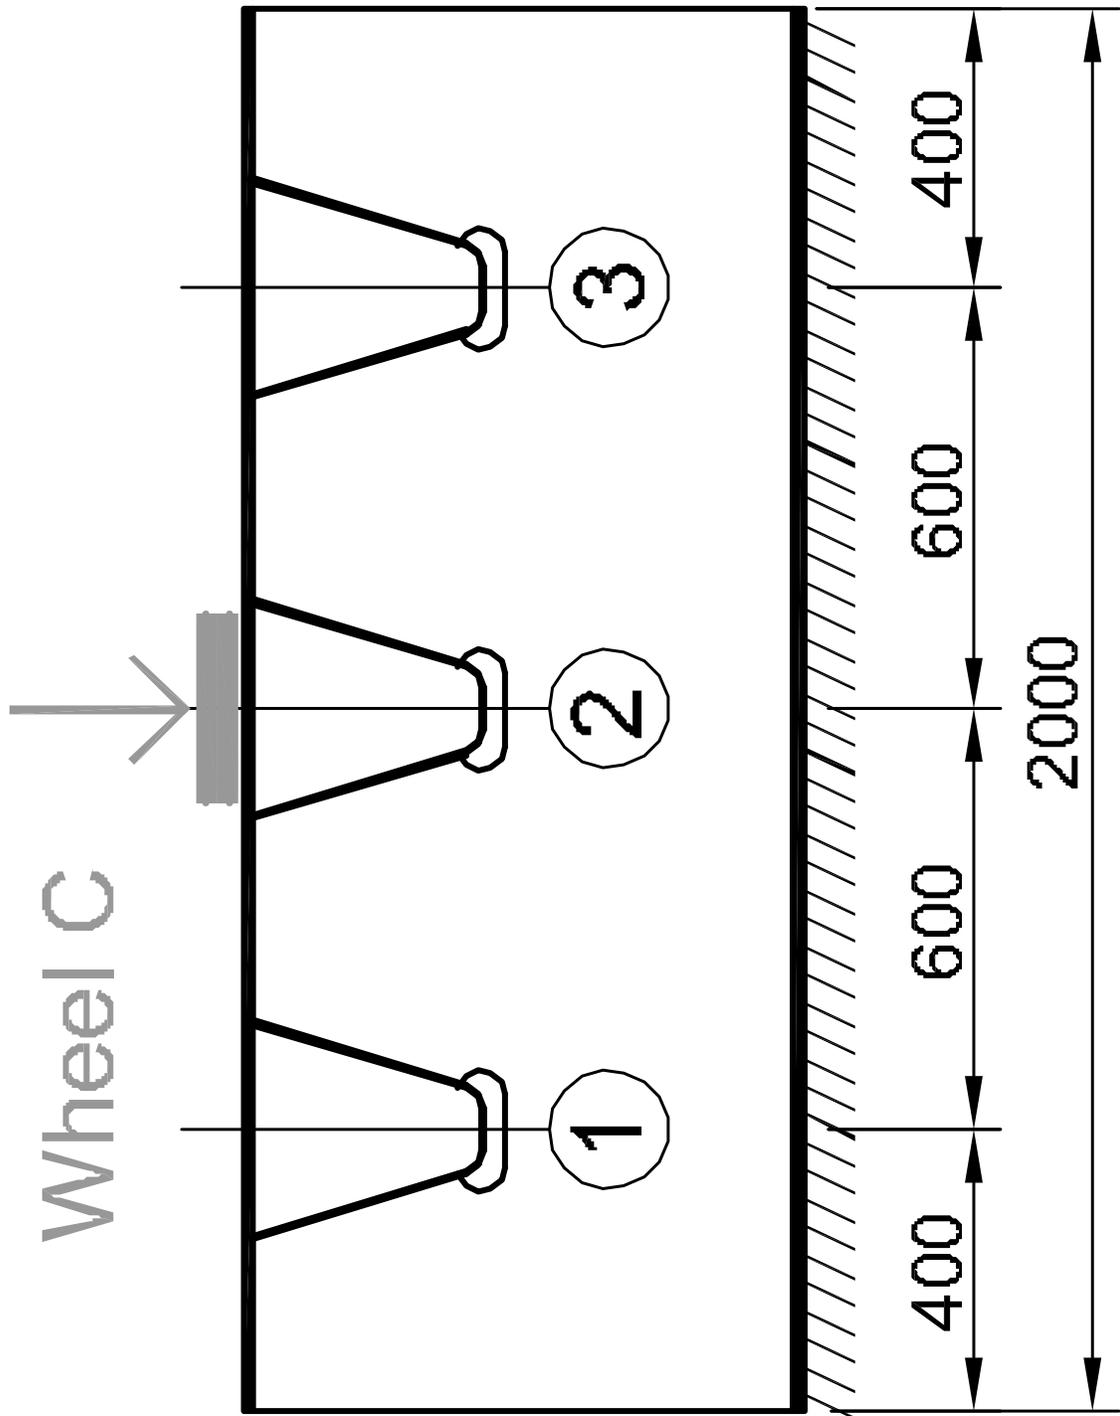
Figure6

110 The bottom flanges of the two crossbeams were clamped to the ground. Figure 6 shows a photo of the test set up. The
111 load was applied on the deck through a 30 mm thick steel plate and 30 mm thick rubber plate, with the rectangular area of the
112 wheel print type C.

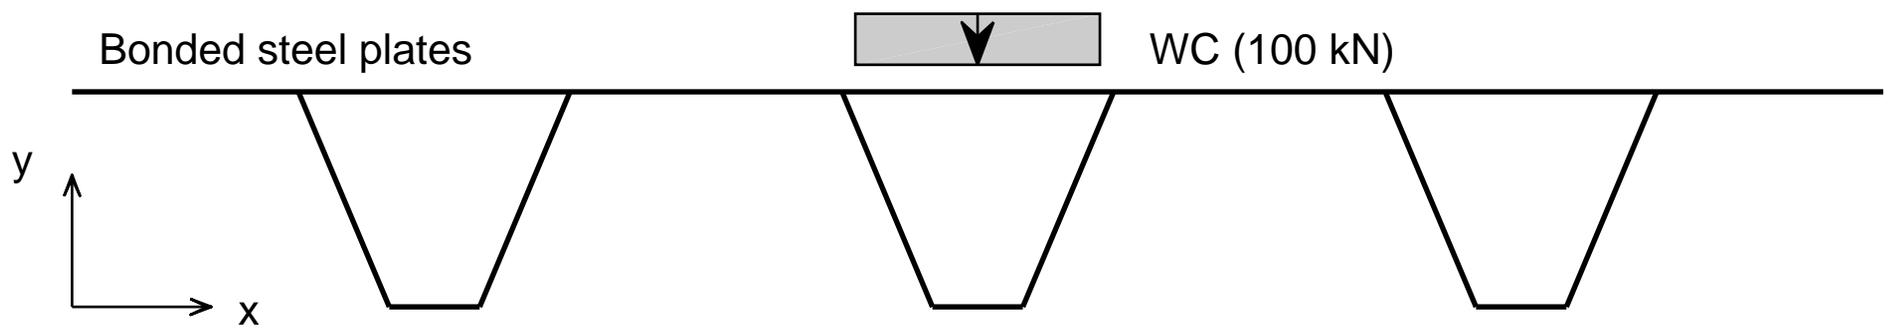
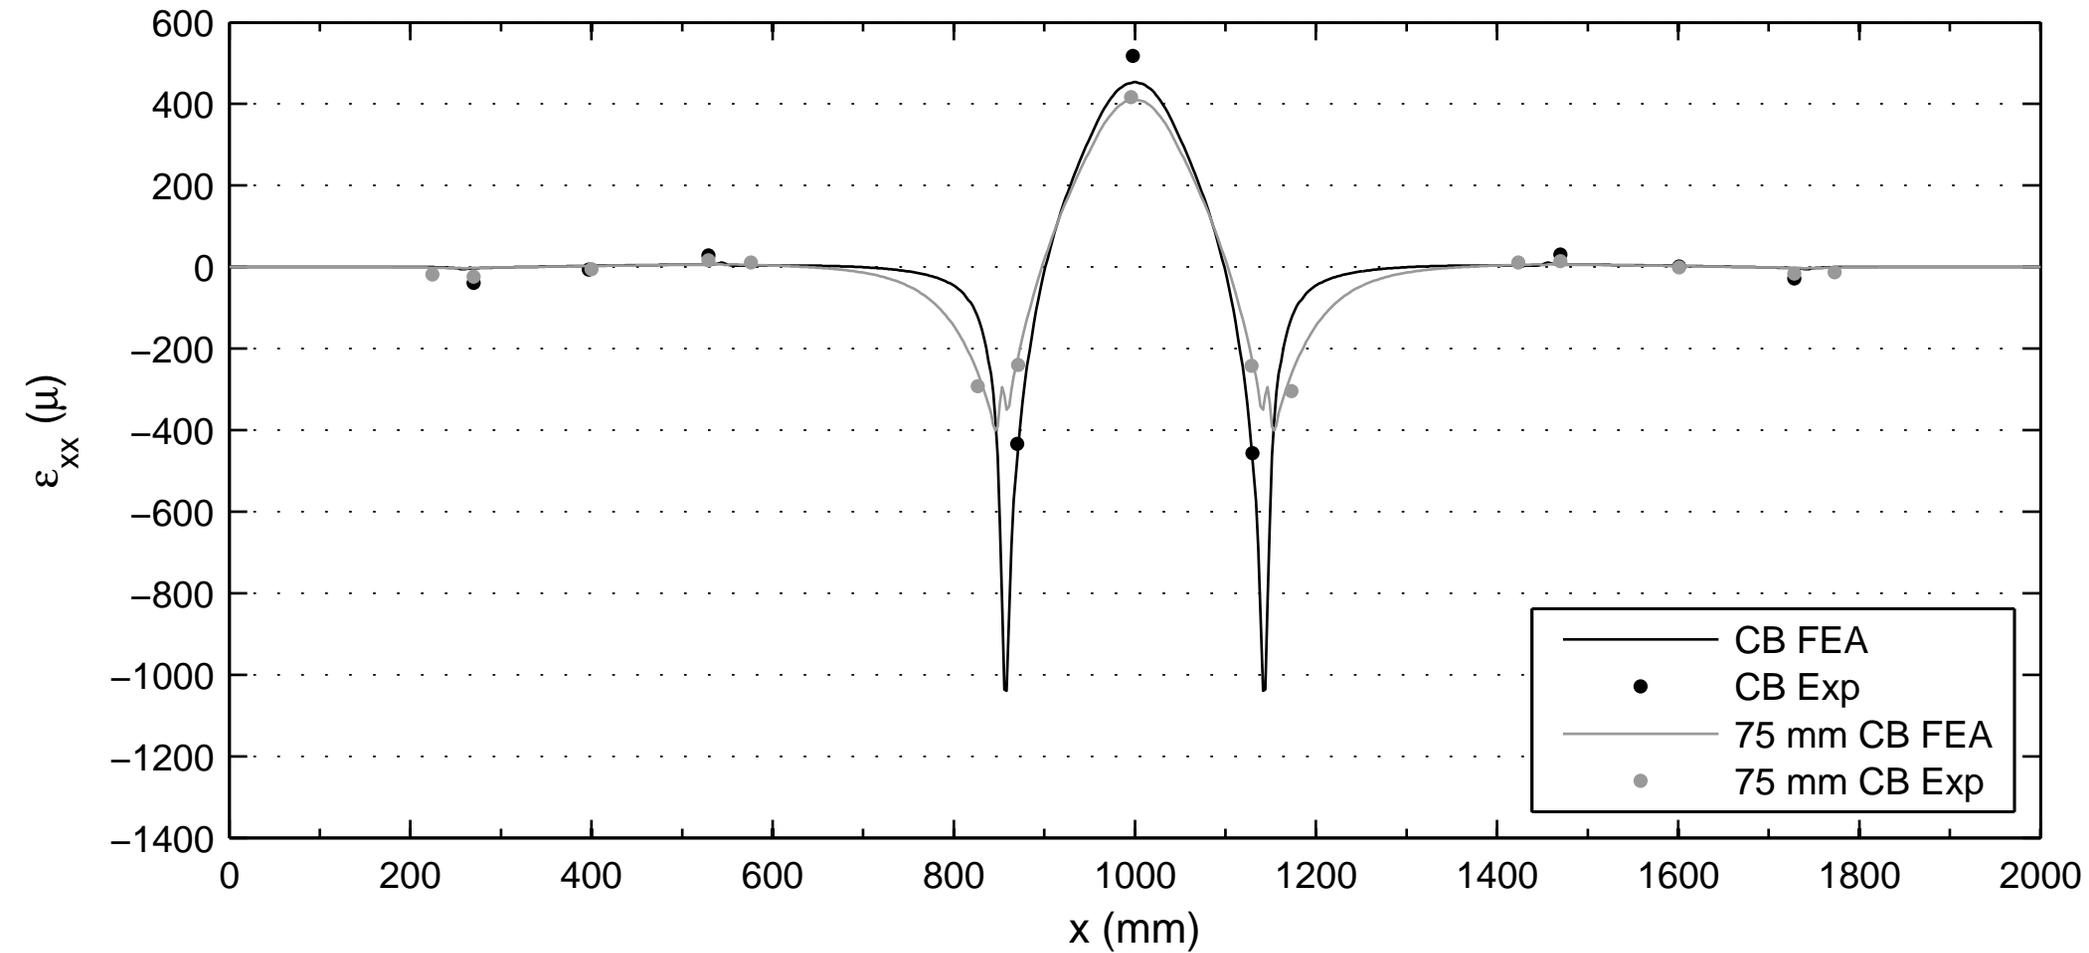
144 In order to validate the numerical results, the strains measured by the strain gauges during the static tests are compared
145 with the strains from the FEM. Figure 8 shows the transverse strain values measured during a static test with 100 kN wheel
146 type C positioned at the cross beam location, both for the bonded system and the sandwich system. The transverse strains on
147 the bottom side of the deck plate measured by the strain gauges at the crossbeam and at 75 mm from the crossbeam are

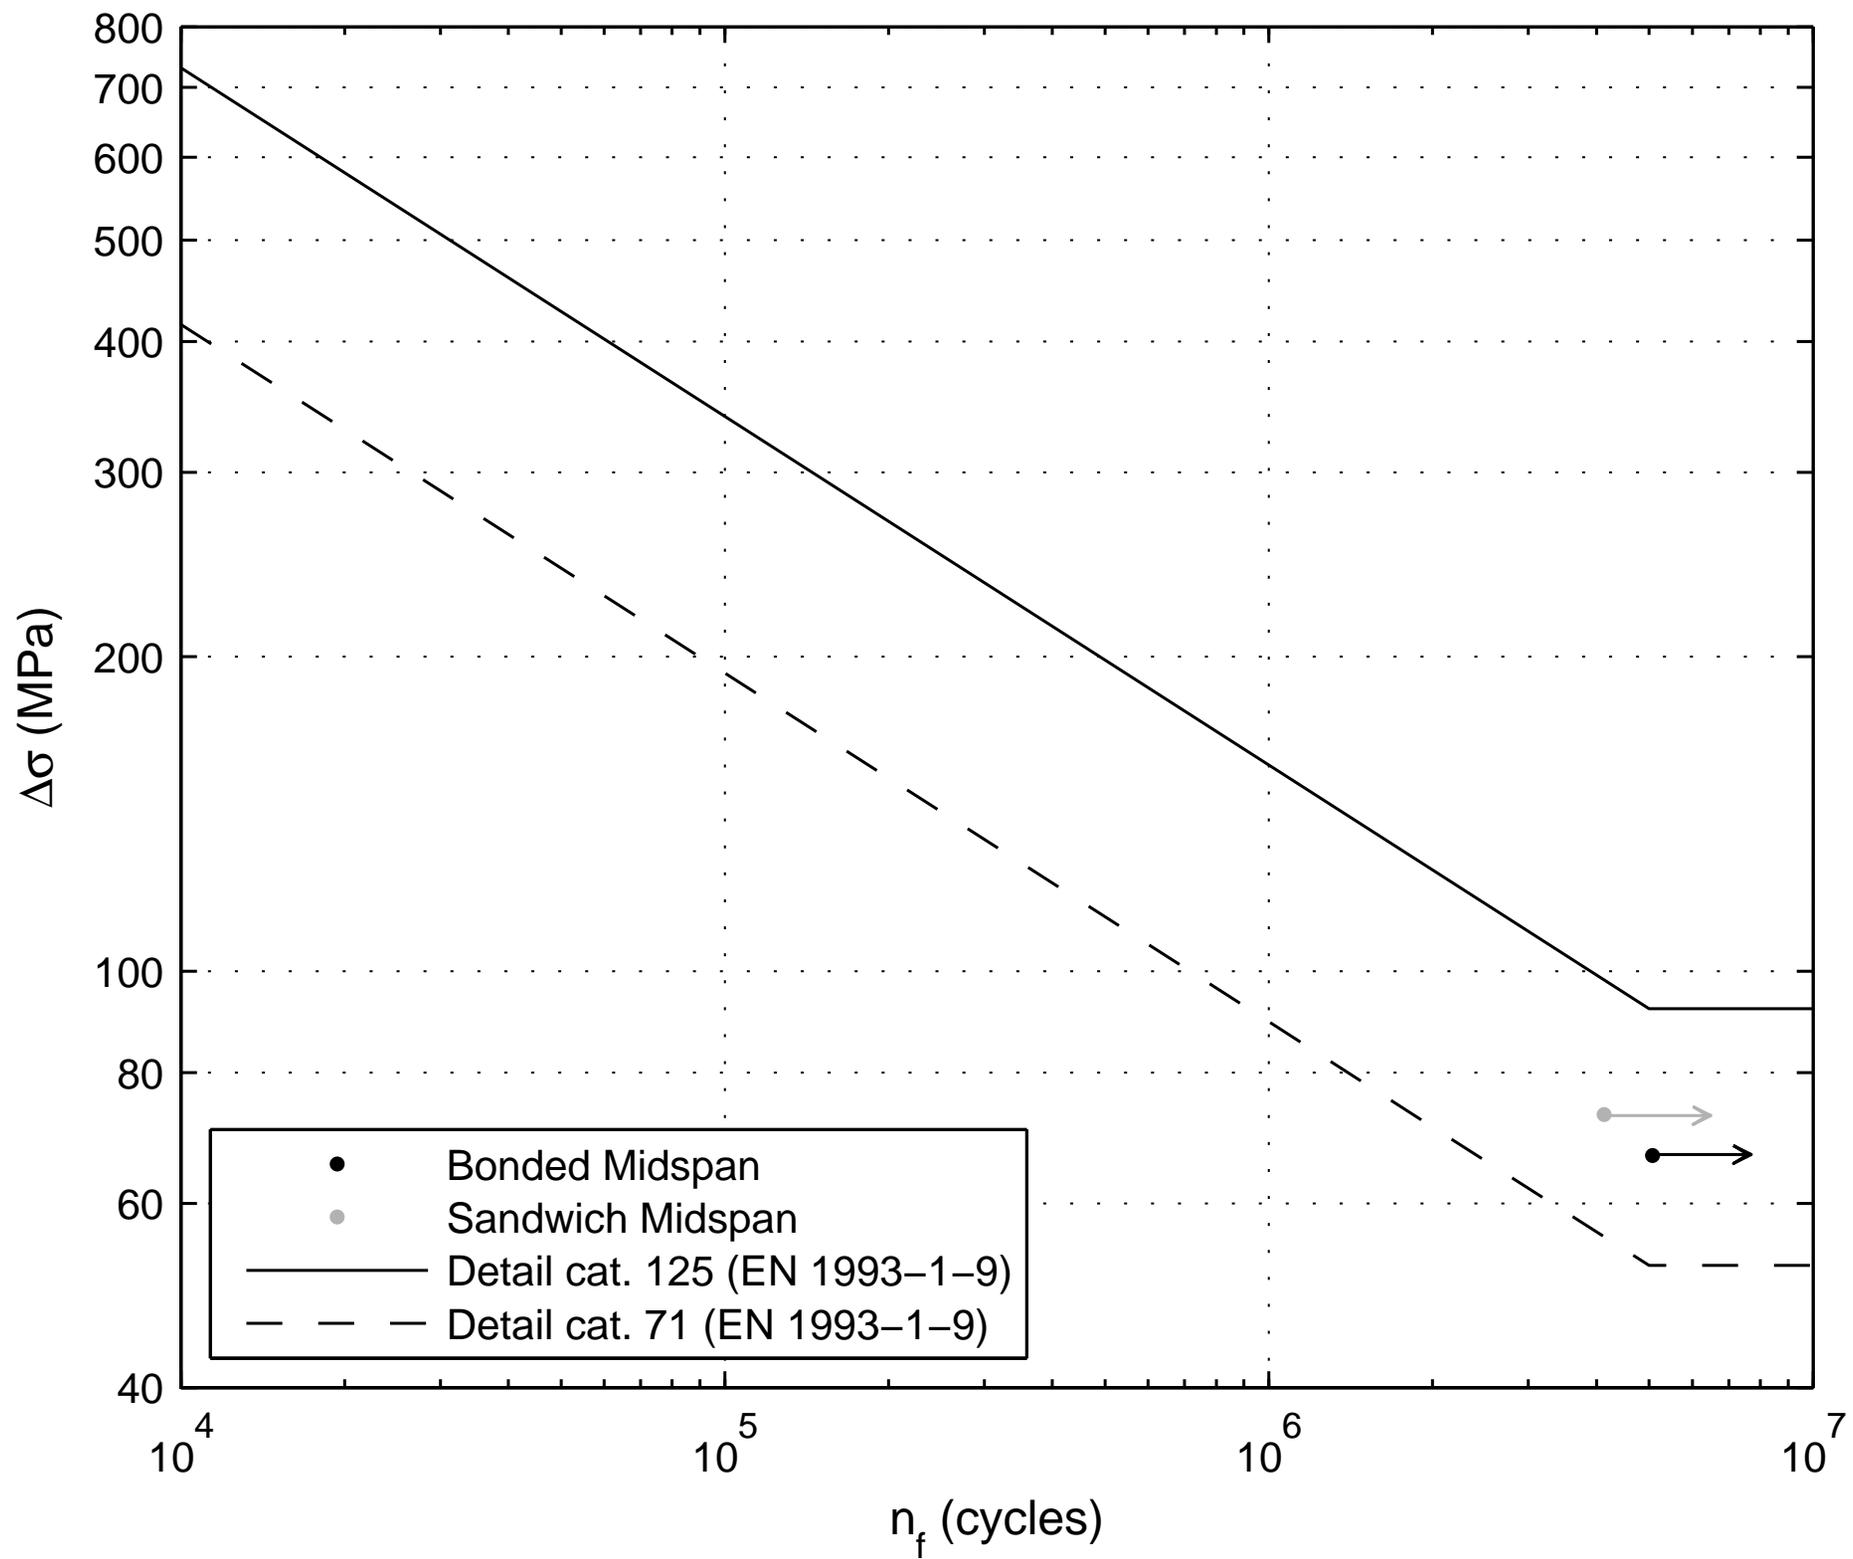
Figure16

290 Figure 16 shows the SN results of the welds at midspan between crossbeams. As no fatigue cracks were found, all results
291 are run-out tests. The stress range was determined by the nominal stresses at the deck plate at the stiffener web location. The
292 results are compared with the details category for the fatigue strength of these welds recommended by Kolstein (2007) (125
293 detail category) and by at EN1993-1-9 (2005) (71 detail category). The results are below the constant amplitude fatigue limit
294 ($\Delta\sigma$ at 5 million cycles) of the 125 detail category, which explains the absence of fatigue cracks at this location.
