# Investigation on Energy Director-less Ultrasonic Welding of Polyetherimide (PEI)- to Epoxy-based Composites

Eirini Tsiangou<sup>a,\*</sup>, Sofia Teixeira de Freitas<sup>a</sup>, Irene Fernandez Villegas<sup>a</sup>, Rinze Benedictus<sup>a</sup>

<sup>a</sup> Aerospace Structures and Materials Department, Faculty of Aerospace Engineering, Delft University of Technology, Kluyverweg 1, 2629HS Delft, The Netherlands

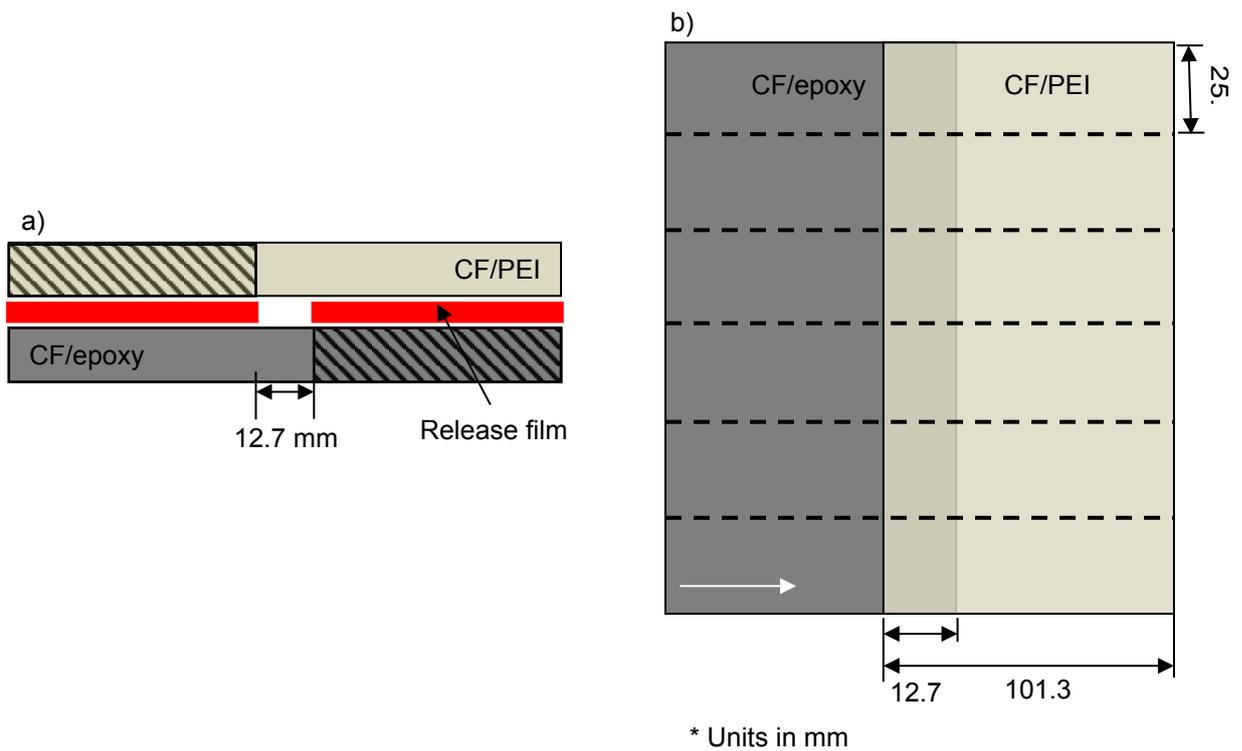
Figure 1: Schematic representations of a) the manufacturing of the reference co-cured samples and b) the location of the cuts, represented by the dash lines. The white arrow points at the 0° fibres of the CF/epoxy adherend and the main apparent orientation of the fibres of the CF/PEI adherend. Dimensions are not to scale.

CF/epoxy laminates directly co-cured with CF/PEI laminates were manufactured as co-cured reference specimens. **Note that, in this case, a neat PEI film was not used on top of the CF/epoxy laminate, because at 180 °C the PEI resin is still in solid state, hence it cannot adhere to the CF/PEI adherend.** An uncured CF/epoxy prepreg stack and a consolidated CF/PEI laminate were first cut in 200 mm-length and 200 mm-width and then stacked. In order to produce samples with a single-lap configuration, two release films were placed between the uncured CF/epoxy and the CF/PEI laminates with a gap of 12.7 mm, as seen in Figure 1a. Afterwards, the stack was co-cured following the same autoclave cycle mentioned above for the CF/epoxy laminate. The release films allowed for the two materials to be co-cured only at the desired location. Subsequent to the co-curing process, the parts indicated with the diagonal lines in Figure 1a were cut out, in order to produce the single-lap specimens. Finally, the individual specimens were cut in 25.4 mm-width dimension, as seen in Figure 1b.

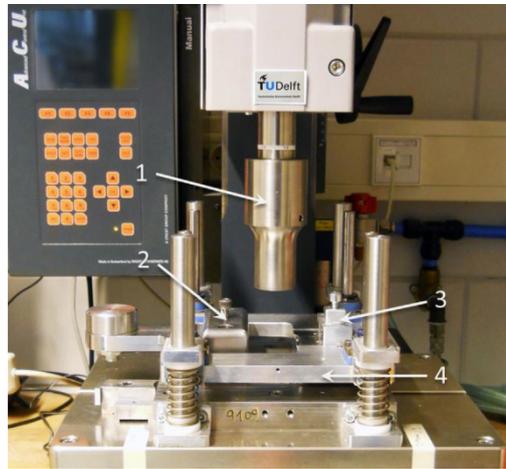
Figure 2: Custom made welding setup. 1: sonotrode, 2: clamp for the lower sample, 3: clamp for the upper sample and 4: sliding platform. [9]

Individual samples were welded with a Rinco Dynamic 3000 ultrasonic welder in a single lap configuration, with the overlap being 12.7 mm long and 25.4 mm wide. The custom-made welding jig shown in Figure 2 was used. A cylindrical sonotrode with a 40 mm diameter was utilised. To ensure minimum heating times, and hence minimum risk of thermal degradation at an acceptable level of dissipated power, the parameters chosen were 1500 N welding force and 86.2  $\mu\text{m}$  peak-to-peak vibration amplitude. These parameters, which are close to the highest within the limits of the machine, result in very short heating times [3]. Solidification force and time were kept constant at 1500 N and 4 s respectively. The duration of the vibration phase was indirectly controlled through either the downward displacement of the sonotrode or the dissipated energy, as it will be explained in more detail in section 3.2. The variation of the power and displacement of the

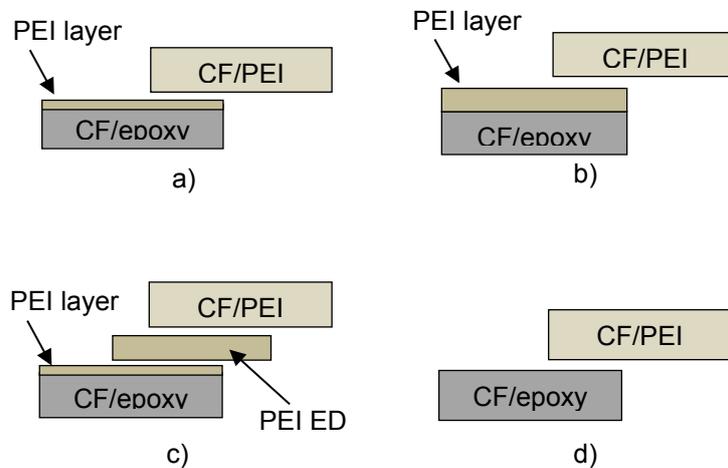
*Figure 3: Schematic representation of CF/PEI- CF/epoxy/PEI stack for the a) ED-less-60 case, b) ED-less-250 case, c) reference ED case and d) reference co-cured case. Dimensions are not to scale.*

Figure 3 shows the schematics of the different types of joints that were developed in this study. The schematics correspond to (a) joints welded through a 60  $\mu\text{m}$ -thick coupling layer, hereafter referred to as ED-less-60 case, (b) joints welded through a 250  $\mu\text{m}$ -thick coupling layer, hereafter referred to as ED-less-250 case, (c) reference joints welded with a 250  $\mu\text{m}$ -thick loose ED and a 60  $\mu\text{m}$ -thick coupling layer, hereafter referred to as welded reference ED case and (d) co-cured reference joints. **In the reference ED case, the ED was fixed on top of the CF/epoxy adherend with adhesive tape (the size of the ED was slightly bigger than the size of the overlap).**

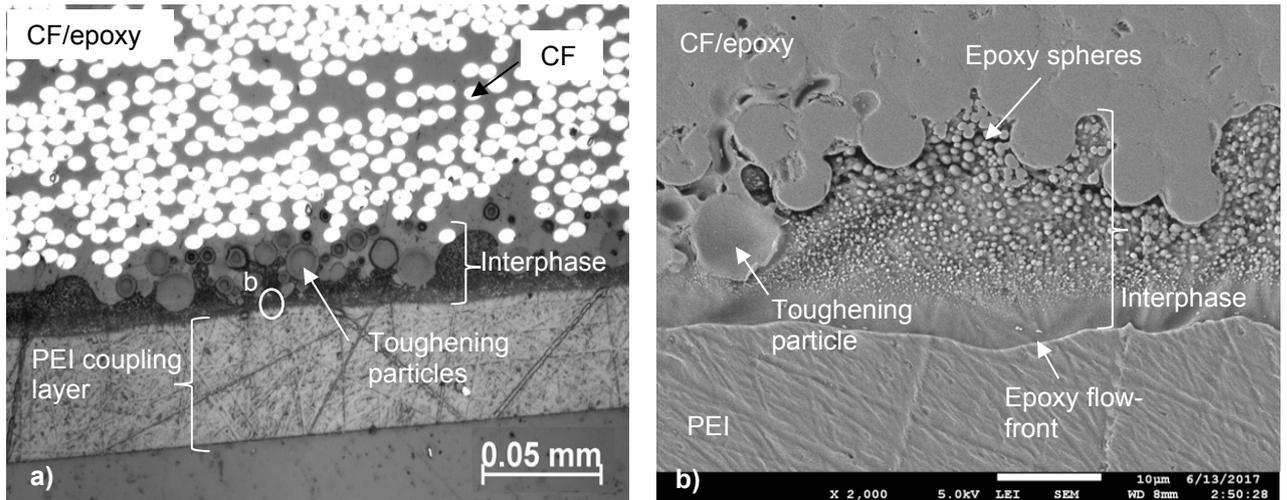
Figure 4: Cross-section images of an etched sample cut from the CF/epoxy/PEI laminate obtained via a) optical microscopy, in which the interphase can be seen as a dark grey area between the epoxy and the PEI resin (both with lighter grey colours) and b) SEM, which shows an interphase with a gradient morphology.

This section aims at i) answering whether an interphase was formed between the T800s/3911 prepreg and the PEI coupling layers, and the T800s/3911 prepreg and the CF/PEI adherend in the co-cured reference joints, after the co-curing process and ii) describing the interphase morphology. **Figure 4a** shows the optical micrograph of an etched CF/epoxy sample with the 60  $\mu\text{m}$  thick PEI coupling layer. A darker grey area can be seen in between the epoxy matrix, which

is a lighter grey colour, and the PEI, which shows scratches that were exposed by the etching process. Note that the spherical particles present in the epoxy resin, with diameters between a few  $\mu\text{m}$  and  $10\ \mu\text{m}$ , are thermoplastic toughening particles present in the T800s/3911 prepreg. A closer look to the circled area (b) in Figure 4a is presented in the SEM image of Figure 4b. In this image is shown that the above-mentioned darker grey area corresponds to the interphase that was formed between the epoxy and PEI materials during the co-curing process. The interphase consists of epoxy spheres dispersed in a PEI-rich matrix, with diameters decreasing towards the PEI coupling layer. Similar interphase morphologies have been seen in previous works, in which PEI was co-cured with a Hexply M18/1 (Hexcel) prepreg [5] or epoxy resins with different formulations [7], [10]–[12]. As explained in those studies, during the co-curing process, the liquid-reactive epoxy system acts as a solvent of the PEI resin. This results in the epoxy monomers diffusing into the glassy PEI and partially dissolving it. Partial dissolution of the PEI polymer allows at the same time for diffusion of the PEI into the liquid epoxy resin. This interdiffusion process between the epoxy and PEI systems stops once the epoxy resin reaches the gelation point. Because of the limited miscibility between the rubbery epoxy and the PEI resins, phase separation occurs. This results in a gradient concentration of the two polymers, hence a gradient interphase between the two materials, with the morphology seen in Figure 4b. The epoxy flow front into the PEI material is also visible in Figure 4b. The area between this flow front and the smallest visible epoxy spheres, with an apparently smooth texture corresponds, most likely, to either an area in which the concentration of the epoxy monomers in the PEI resin was very low, resulting in no phase separation of the two resin systems, or an area with epoxy spheres with a size that was not resolved by the microscope. The thickness of the interphase varies and has a maximum value of around  $25\ \mu\text{m}$ . The same interphase morphology was observed in the co-cured T800s/3911 prepreg and  $250\ \mu\text{m}$ -thick coupling layer.

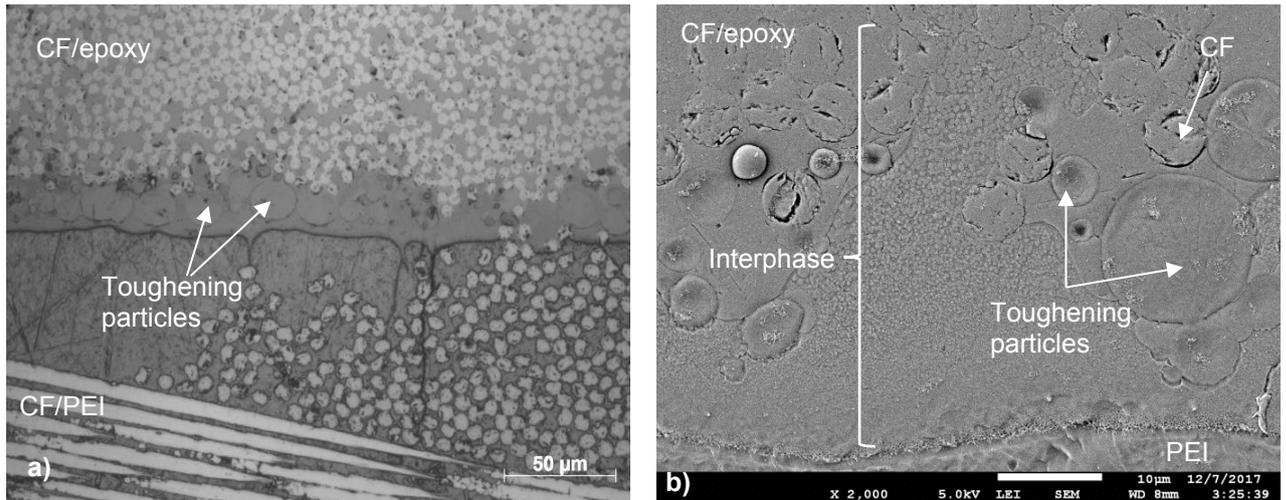
Figure 5: Cross-section images of etched co-cured reference sample obtained via a) the optical microscope, in which no signs of a formed interphase can be seen, and b) the SEM, which shows that an interphase is formed with epoxy spheres embedded in the PEI resin.

Figure 5a presents the optical micrograph of an etched reference co-cured sample. As shown in the image, the interphase is not visible with optical microscopy, therefore SEM analysis is necessary to examine whether an interphase was formed. The SEM image in Figure 5b shows the existence of an interphase similar to the one formed in the CF/epoxy/PEI laminates, with epoxy spheres dispersed in the PEI-rich matrix resin, indication of inter-diffusion between the epoxy and PEI matrices. However, the two interphases have a different maximum thickness, with the interphase of the co-cured reference sample being almost 40 µm, whereas for the interphase formed with the neat PEI film the thickness is 25 µm. Epoxy spheres can be found deeper into the CF/epoxy laminate, in the interphase of the co-cured reference sample. The density of the epoxy spheres in the PEI resin also seems to be higher for the co-cured reference samples. The reason why the interphase formed between the CF/epoxy and CF/PEI prepregs shows some differences, might be a different PEI grade between the 60 microns SABIC PEI coupling layer and the Cetex® CF/PEI prepreg of the TPC adherend (reference co-cured case).

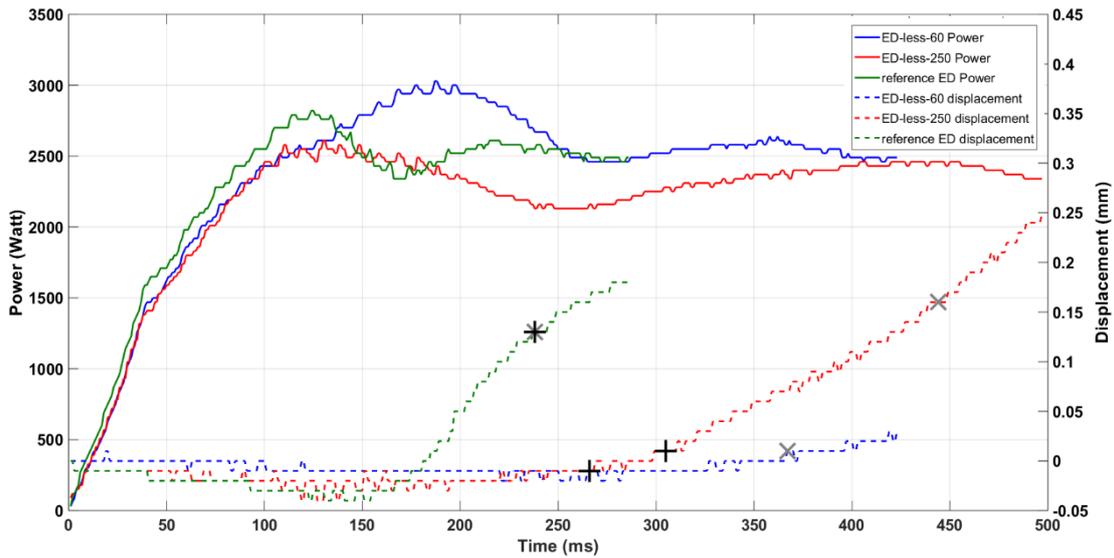
Figure 6: Representative power (solid line) and displacement (dotted line) curves of samples welded according to the three different welding cases. The grey “x” points indicate the initial expected optimum displacement values, according to the procedure defined for ultrasonic welding of TPCs with a loose ED [13]. The black “+” points indicate the actual optimum displacement values used for the welding.

Figure 6 illustrates the representative power and displacement curves plotted versus time of samples welded according to the three welding cases shown in Figure 3, namely the ED-less-60, ED-less-250 and the reference ED cases. The curves correspond to displacement-controlled process in which the downward movement of the sonotrode reached the total thickness of the coupling layer, for the ED-less cases, or the thickness of the ED for the reference ED case. Two power peaks can be found in the power curves of all cases. The displacement stays at around zero during the first power peak. The time during which the displacement is zero, however, differs per case. This stage lasts approximately 250 ms longer for the ED-less cases, as compared to the reference ED case. The displacement starts increasing when the power starts increasing after the first peak. The rate at which the displacement increases is the fastest for the reference ED case and the slowest for the ED-less-60 case.

In welding of TPCs the power and displacement curves are used to determine the optimum duration of the vibration phase [13]. It is shown in [13] that stopping the welding process close to when the second power peak occurs, results in welds with the highest strength. In the reference ED case, samples welded in displacement-control mode with a target displacement of 0.13 mm (which corresponds to the second power peak) featured, upon mechanical testing, no signs of overheating and satisfactory strength values, as it will be shown in section 3.4.2. In the ED-less-60 case, the second power peak corresponded to zero displacement and hence an energy-controlled process had to be used. Through a trial-and-error process, it was found that welding between 500 J (which corresponds to the second increase in power and is indicated with the black “+” point in Figure 6) and 700 J (which corresponds to the second power peak, indicated with the grey “x” point), resulted in welds with similar strength. All of them featured unwelded areas and degradation signs of the PEI resin, as it will be shown in section 3.4.2. Hence, to minimise the thermal effects, 500 J was chosen as the optimum energy. In the ED-less-250 case, samples welded with a target displacement of 0.15 mm (expected optimum displacement, indicated with

the grey “x” point in Figure 6) featured, upon testing, fibre distortion in the CF/PEI adherend, potentially due to excessive PEI resin flow [14]. A trial-and-error process had to be followed, in order to find more adequate welding conditions. It was found that the welds with the highest mechanical performance and least fibre distortion were achieved for an energy value of 600 J (black “+” point in Figure 6) . Note that energy-controlled welding had to be used since the vibration had to be stopped close to the onset of the downward displacement of the sonotrode, therefore at approximately zero displacement, as seen in Figure 6.

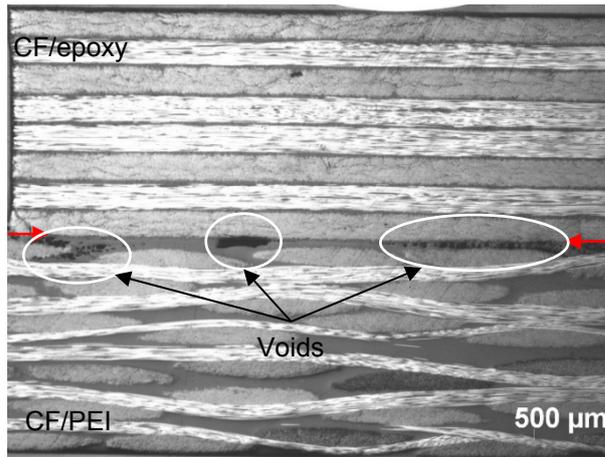
Figure 1: Cross-sectional micrograph close to the edge of an ED-less-60 sample welded at 500 J. Porosity can be seen within the weld line. Red arrows indicate the weld line.

In order to evaluate the effect of the welding process on the integrity of the welding stack, i.e., the adherends, the coupling layer and the interphase, cross-sectional analysis of as-welded samples was performed. The main focus points of this analysis were (i) to determine the thickness of the weld line, since it is an indication of how much neat resin has flowed and it can also have an influence on the mechanical performance of the joints, and (ii) to identify thermal degradation signs in the form of porosity. Note that the weld line is defined in this study as the PEI-rich region between the fibre bundles of the CF/epoxy and CF/PEI adherends. Figure 7 shows the optical micrograph of the cross-section of an ED-less-60 sample. Porosity within the weldline and the first ply of the CF/PEI adherend can be observed, as seen in the circled areas in [Figure 7](#). The weldline has a thickness of around 70  $\mu\text{m}$ . Figure 8 presents the cross-sectional optical micrograph of an ED-less-250 sample. Some porosity can be seen near the edge of the overlap and close to the CF/PEI adherend. The thickness of the weldline is approximately 200  $\mu\text{m}$ .

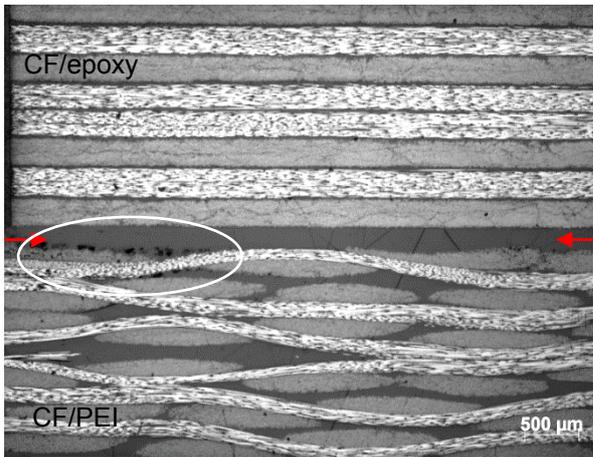
Figure 8: Cross-sectional micrograph close to the edge of an ED-less-250 case sample welded at 600 J. A thick weld line and porosity in the weld line can be observed. Red arrows indicate the weld line.

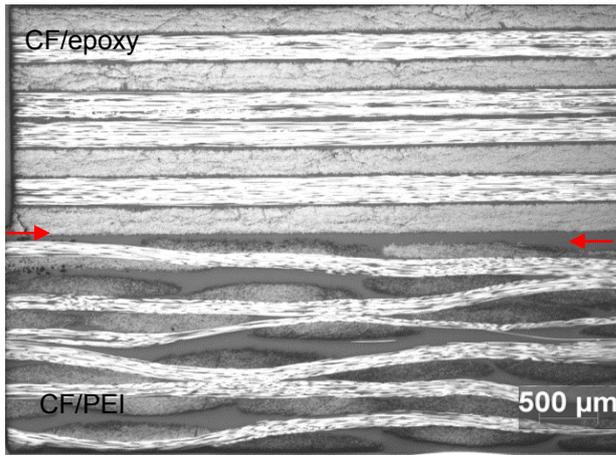
*Figure 9: Cross-sectional micrograph close to the edge of a reference ED sample welded at 0.13 mm displacement revealing no porosity in the weld line. Red arrows indicate the weld line.*

Figure 9 presents an optical micrograph of a reference ED sample. No signs of porosity within the weld line and in the two composite adherends can be found. The thickness of the weld line is approximately 110  $\mu\text{m}$  and it seems to be similar to the ones typically observed in literature for ultrasonically welded TPC joints [15,16]. The thickness of the weld line decreases towards the edges, where squeeze out of resin occurs.

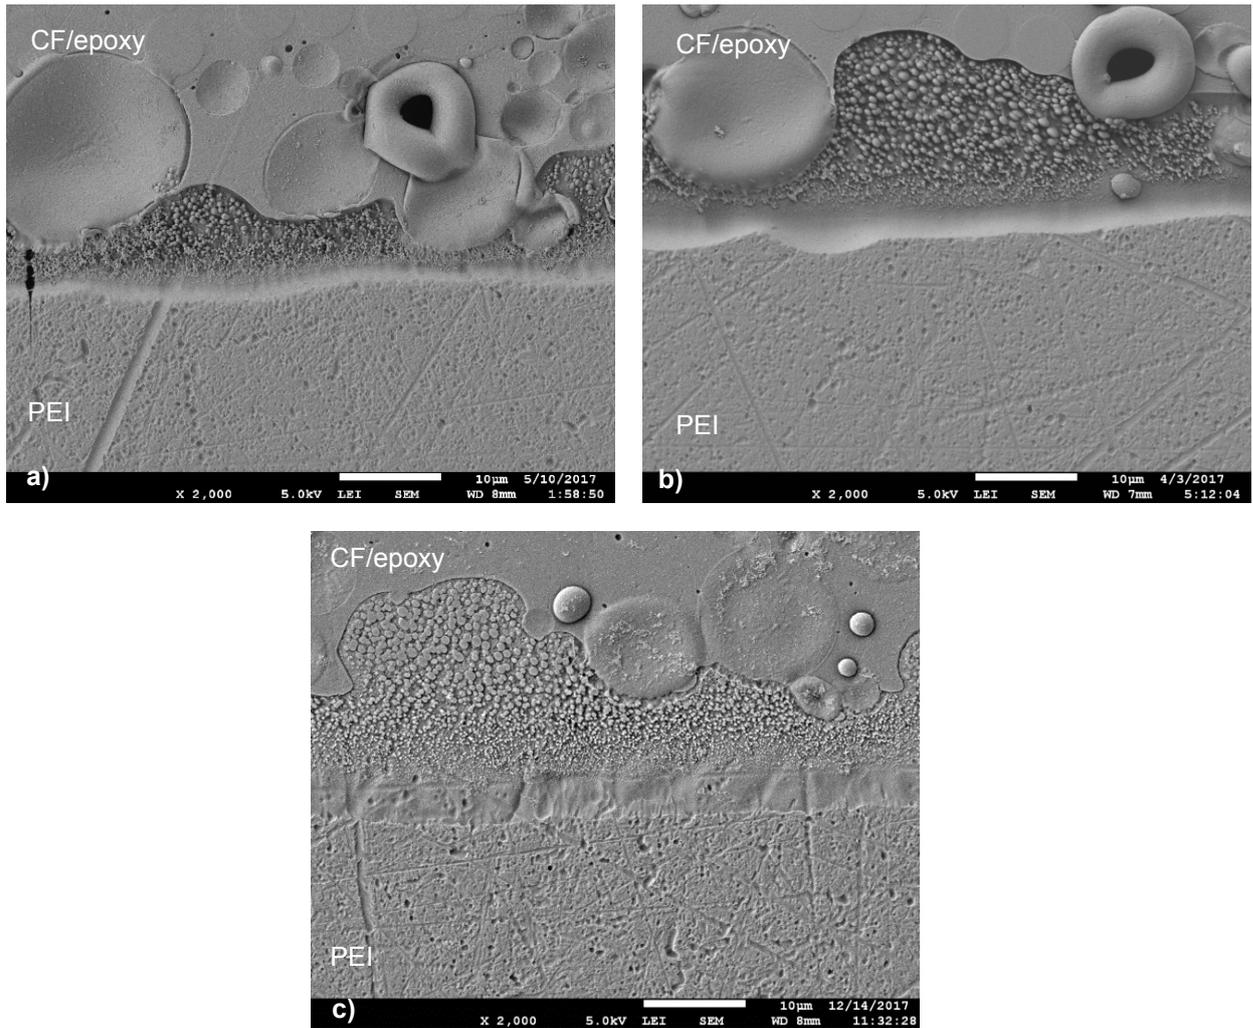
Figure 10: SEM images of as-welded specimens for the (a) ED-less-60, (b) ED-less-250 and (c) reference ED cases. The interphase morphology is the same for all welding cases.

During the welding process, it is likely that the coupling layer will soften and flow, especially in the ED-less cases, in which the coupling layer is expected to act as an integrated ED. Hence, it could happen that flow of the coupling layer close to the interphase altered the initial interphase morphology between the epoxy matrix and the PEI film. In order to assess whether the welding process affected the interphase, SEM analysis of the cross-sections presented in the previous section was performed. Figure 10 depicts the SEM images of as-welded specimens for each welding case. It is observed that for all cases the post-welded interphase has the same morphology as the original one.

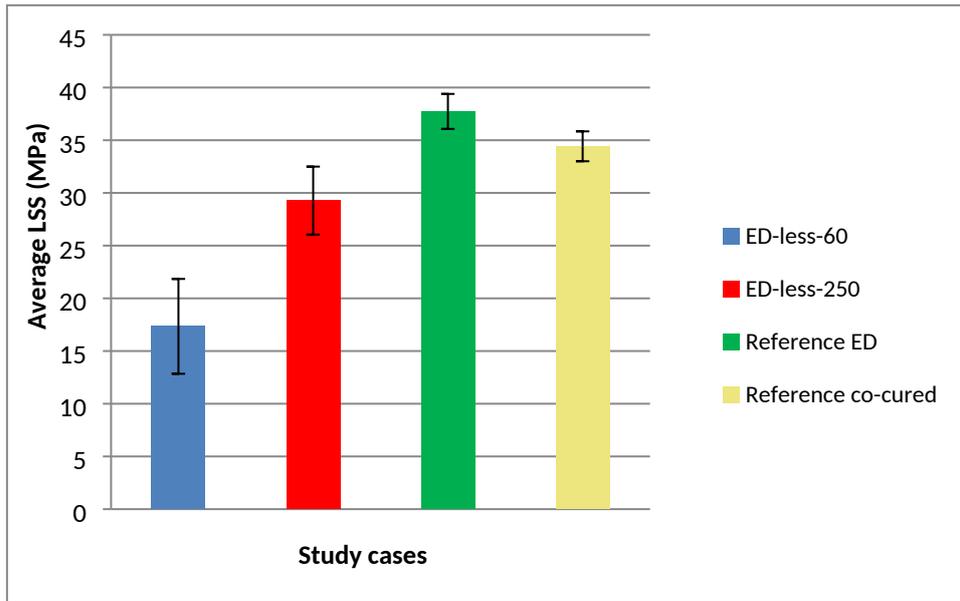
Figure 11: LSS values of the reference and welded samples with corresponding standard deviation.

The results of the single-lap shear tests are illustrated in Figure 11. The ED-less-60 samples have a LSS of  $17.3 \pm 4.5$  MPa (average  $\pm$  standard deviation) with a 26% coefficient of variation (cov), while the ED-less-250 case samples have a LSS of  $29.3 \pm 3.2$  MPa (11% cov). The LSS of the reference ED samples is the highest with the lowest scatter amongst the welded samples, i.e.  $37.7 \pm 1.6$  MPa (4% cov). The co-cured samples exhibit a LSS of  $34.7 \pm 1.4$  MPa (4% cov).

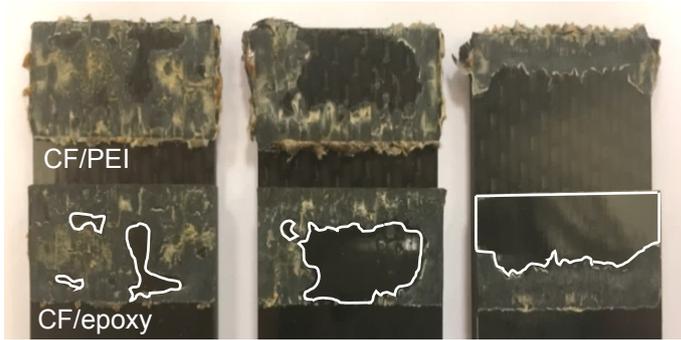
*Figure 12: Fracture surfaces obtained from ED-less-60 samples welded at 500 J. The white lines indicate the unwelded areas.*

Fractographic analysis was used in order to further evaluate the mechanical performance of the joints. Figure 12 shows three typical fracture surfaces of ED-less-60 samples after testing. Note that they were all welded with the same welding parameter, i.e. 500 J. Unwelded areas covering a significant part of the overlap can be seen in all samples. The amount and location of the unwelded areas are inconsistent per sample and most of the welded areas display discoloured resin that can potentially result from thermal degradation. The lack of exposed fibres indicates that failure occurred entirely in the neat PEI resin, most probably in the coupling layer. The sample exhibiting the highest strength and largest welded areas is chosen for further microscopic analysis (the left most sample in Figure 12), the results of which are presented in Figure 13a.

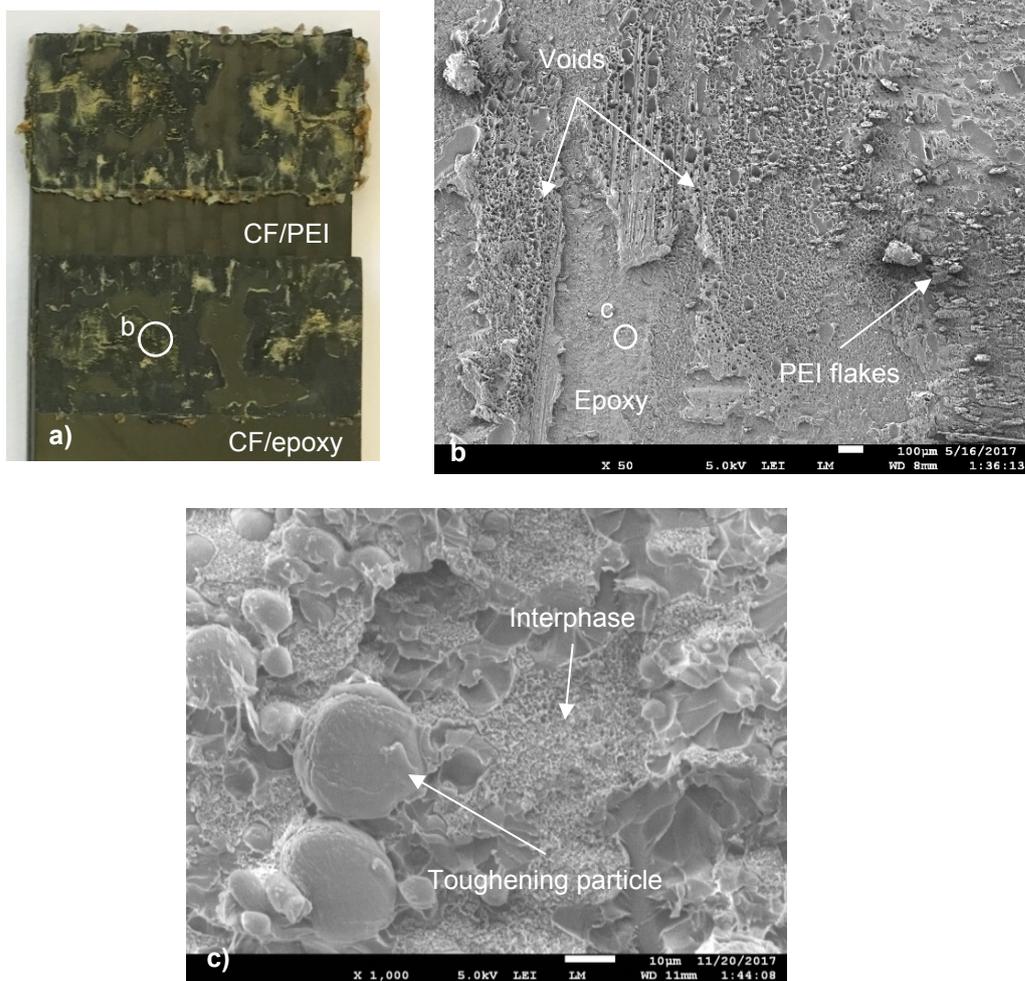
Figure 13: (a) Representative fracture surfaces of an ED-less-60 case sample showing large unwelded areas and signs of thermal degradation of the PEI resin. (b) SEM image corresponding to the circled area in (a), depicting voids in the PEI resin and PEI resin flakes, both features associated with thermal degradation and (c) is a detailed SEM image showing failure in the interphase

Figure 13b depicts a SEM image of the area circled in Figure 13a. Numerous voids and flakes can be seen in the PEI resin, however it is unclear whether they were coming from the coupling layer or the PEI matrix in the CF/PEI adherend. Such features are mostly linked to thermal degradation of the PEI resin, as presented in the work of Palardy and Villegas [15]. A closer examination of the area (c) indicated in Figure 13b, reveals exposed epoxy spheres which are part of the interphase, and toughening particles, which are indications of interphase failure and possibly epoxy matrix failure (Figure 13c).

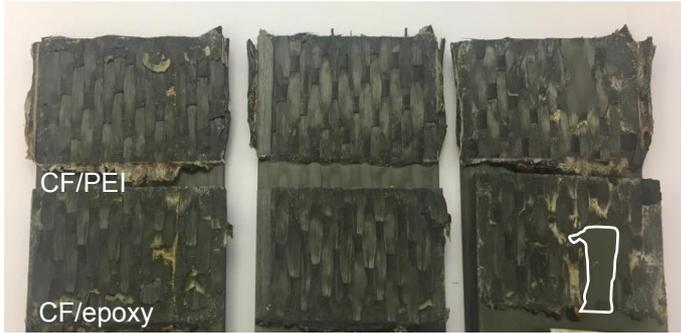
*Figure 14: Fracture surfaces obtained from ED-less-250 samples welded at 600 J. Unwelded areas are indicated by the white lines. White arrows indicate locations with discoloured PEI resin.*

Figure 14 shows three typical ED-less-250 fracture surfaces of samples welded with the same parameters. The fracture surfaces appear more uniform than in the ED-less-60 case and for most samples no unwelded areas are present. The failure mechanism is characterized by first ply failure in the CF/PEI adherend. In some samples, however, like the first and third samples in Figure 14, discoloured PEI resin is seen, similar to what was observed in the ED-less-60 samples. For further analysis the sample exhibiting the highest strength and largest welded area (left most sample in Figure 14) is chosen and is illustrated in Figure 15a.

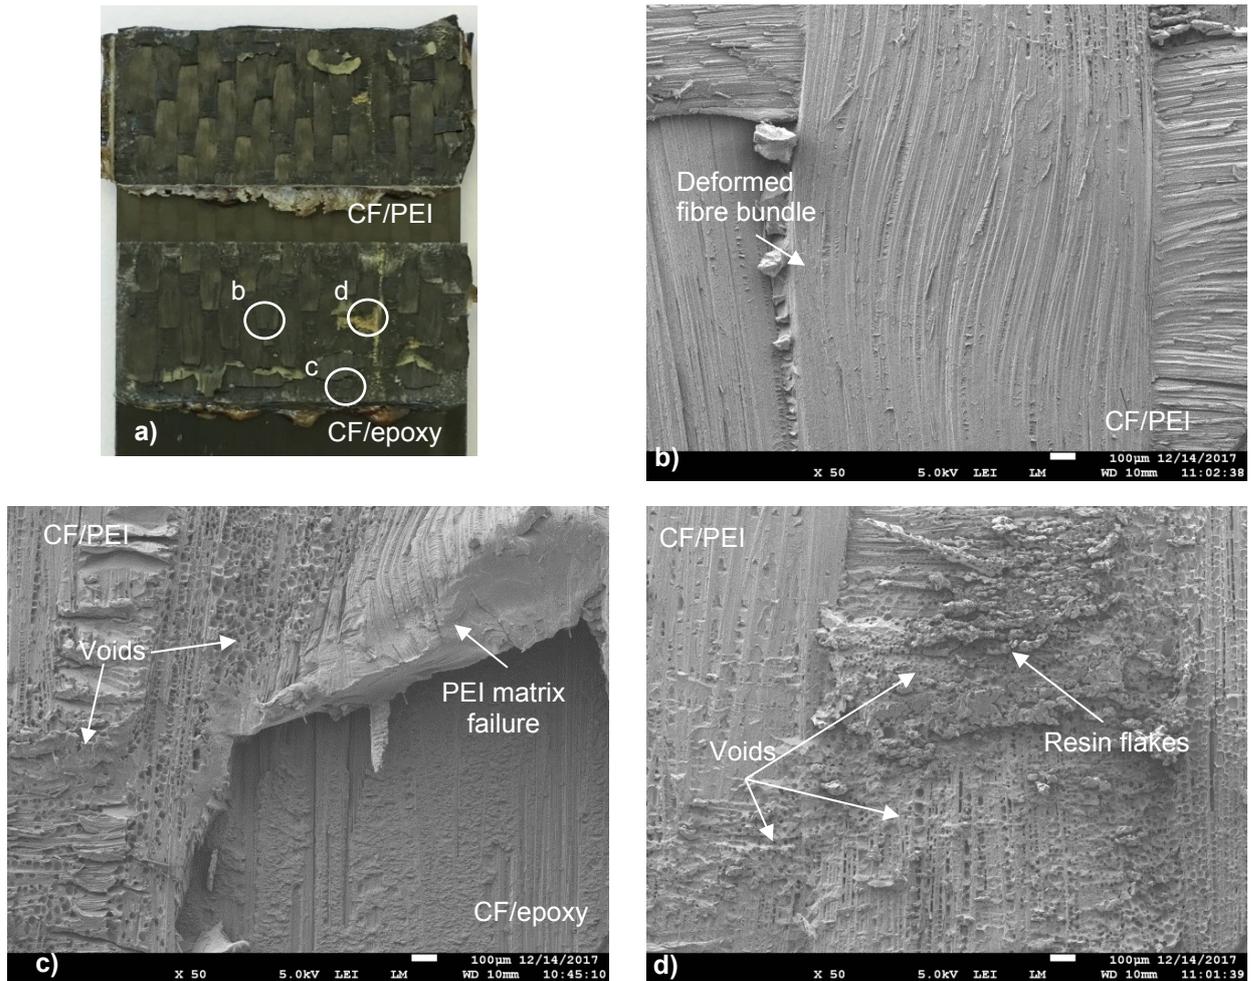
Figure 15: (a) Representative fracture surfaces of an ED-less-250 sample showing failure mostly in the CF/PEI adherend, with only partial failure in the CF/epoxy adherend and (b), (c), (d) are SEM images corresponding to the circled areas in (a), showing (b) deformed fibre bundles (c) degradation signs in the form of voids close to the edge of the overlap and (d) voids and resin flakes in the middle of the overlap.

Figure 15b shows a SEM micrograph of the circled area (b) in Figure 16a and displays slightly deformed fibre bundles in the CF/PEI adherend. In Figure 15c, failure in the CF/epoxy adherend is also partially seen, characterized by mostly matrix failure and only a few exposed fibres or fibre imprints. This failure however is not the predominant type of failure and it is only found at one of the edges of the overlap on the CF/epoxy adherend, as indicated by the circled area (c) in Figure 15a. Numerous voids on the fracture surface of the CF/PEI adherend can be seen at the abovementioned location, indicating thermal degradation of the PEI resin. Degradation signs in the form of voids and resin flakes are also found in an area in the middle of the overlap (region (d) in Figure 15a), depicted in Figure 15d.

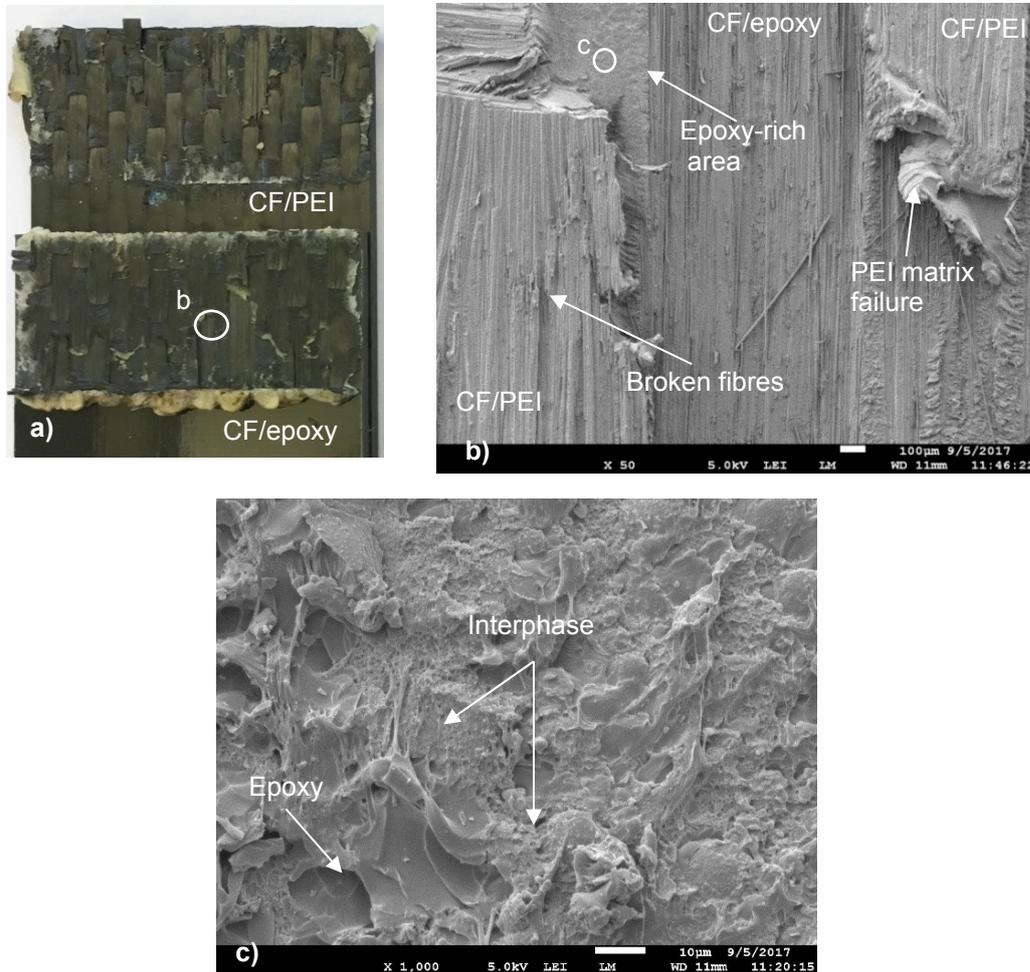
Figure 16: (a) Representative fracture surfaces of a reference ED sample welded at 0.13 mm displacement, showing failure mostly in the CF/PEI adherend, with only partial failure in the CF/epoxy adherend. (b) SEM image corresponding to the circled area in (a), showing broken CF/PEI bundles and exposed fibres in the CF/epoxy adherend, (c) SEM image showing failure in the epoxy and interphase.

Figure 16a shows the representative fracture surfaces of reference ED samples, exhibiting a fully welded overlap. First-ply failure in the CF/PEI adherend is the dominant failure mechanism, indicated by the broken fibre bundles of the CF/PEI adherend that are found on the CF/epoxy adherend. Failure in the CF/epoxy adherend is limited and only some exposed fibres are seen on the fracture surfaces. Such observations are supported by SEM inspection pertaining to the CF/epoxy adherend, as the micrograph in Figure 16b illustrates. The micrograph also shows some epoxy-rich areas. Closer inspection of the epoxy-rich areas reveals failure both in the epoxy

resin and the interphase, presented in Figure 16c. However, such failure type is found only at a few locations in the overlap. No thermal degradation signs of the PEI resin can be observed throughout the fracture surfaces.

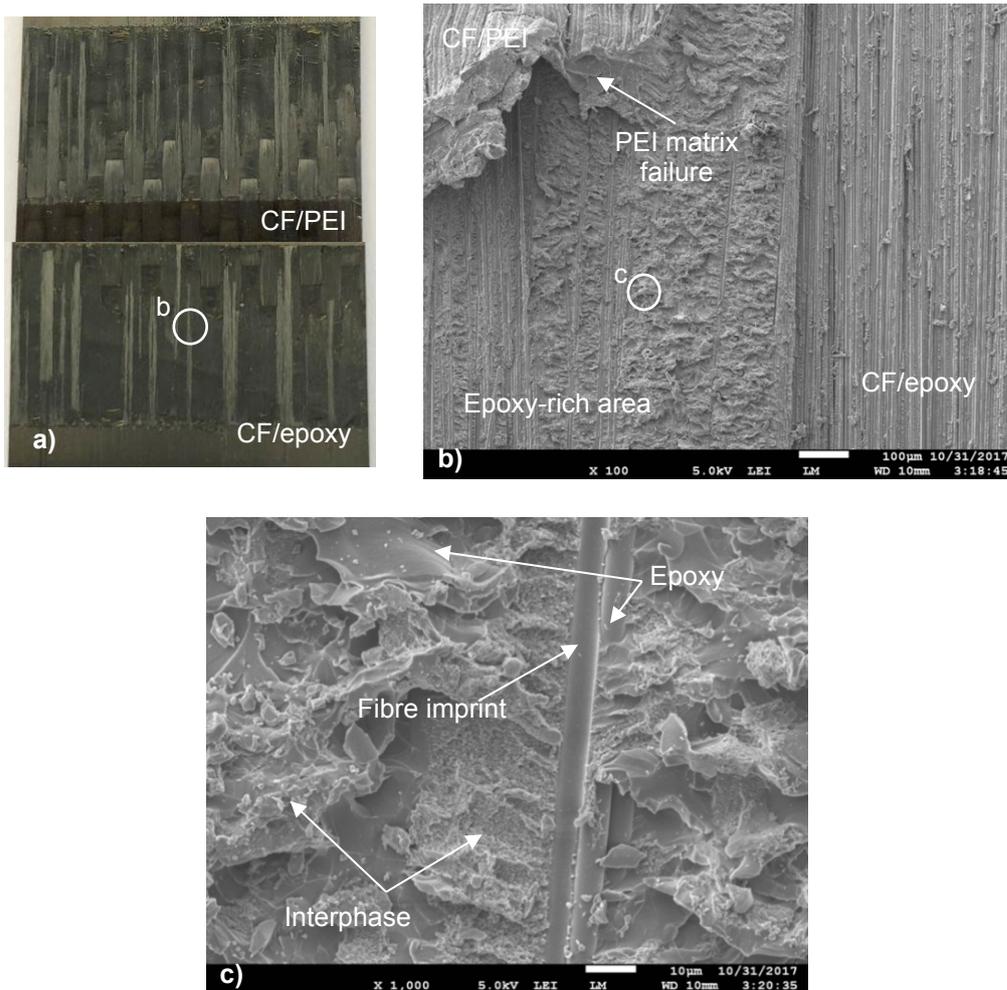
Figure 17: (a) Representative fracture surfaces of a reference co-cured sample, showing failure in the two composites adherends characterised by exposed fibers and resin failure. (b) SEM image corresponding in the circled area in (a), matrix failure in the CF/PEI adherend, exposed fibres in the CF/epoxy adherend and matrix failure. (c) A more detailed SEM image showing failure in the interphase and epoxy matrix.

Figure 17a illustrates representative fracture surfaces for the reference co-cured case. Naked-eye inspection reveals first ply failure in both CF/epoxy and CF/PEI adherends. The failure is characterized by exposed fibres and resin rich areas. Closer inspection of the circled area (b) in

Figure 17a by means of SEM (Figure 17b), shows matrix failure in the CF/PEI adherend, exposed fibres from the CF/epoxy adherend, as well as epoxy resin rich areas. Figure 17c depicts a closer view of the circled area (c) in Figure 17b, in which epoxy resin is fractured, demonstrating matrix failure, and what seem to be epoxy spheres from the interphase are exposed, linked to interphase failure.
