## The use of acoustic emission and composite peel tests to detect weak adhesion in composite structures

Sofia Teixeira de Freitas, Dimitrios Zarouchas & J.A. Poulis

Faculty of Aerospace Engineering, Department of Aerospace Structures and Materials, Group of Structural Integrity and Composites, Delft University of Technology, Delft, The Netherlands

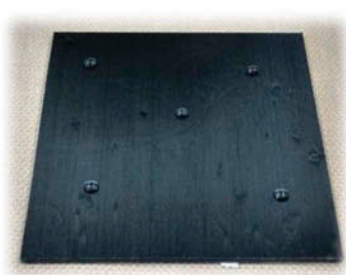
**Figure 2.** Contact angle measurements.

In order to characterise the effect of different surface pre-treatments and of a contamination agent on the CFRP surface, contact angle measurements with distilled water were performed using a Tensiometer (KSV instrument CAM 200, Helsinki, Finland) shown in [Figure 1](#). The lower the contact angle between the drop and the surface, the better the wettability of the surface. This set of experiments was performed on small CFRP specimens (50x50 mm, layup  $[0^\circ]_5$ ). Five specimens were used for each configuration and five contact angle measurements were taken for each specimen at distinctive places of the samples, as shown in [Figure 2](#).

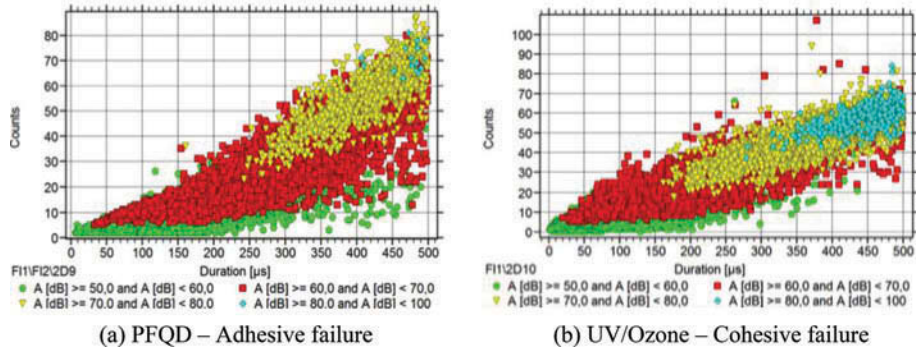
**Figure 17.** The typical number of counts in respect to the duration of measurement for each hit for the specimens treated with PFQD (a) and the specimens treated with UV/Ozone (b).

both specimens. However, different trends were observed for the hits of Group (3); the hits of specimens treated with PFQD range between 20 and 80 counts with duration between 250  $\mu\text{s}$  and 500  $\mu\text{s}$  while the hits of specimens treated with UV/Ozone range between 20 and 70 counts with duration 150  $\mu\text{s}$  and 500  $\mu\text{s}$ .

Furthermore, Figure 17 presents the number of counts of each AE hit in respect to their duration, for the two different specimens. The AE hits of Groups (1) and (2) (highlighted with green and red) show very similar characteristics for
