Interlaminar adhesion assessment of carbon-epoxy laminates under salt water ageing using peel tests

J Materials: Design and Applications

Abstract

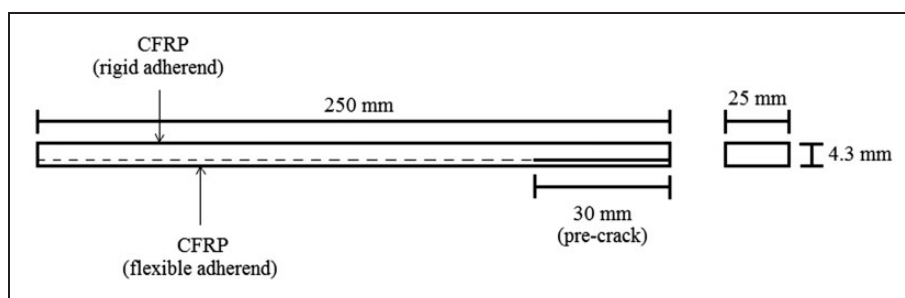
Figure 1. Specimen geometry.

The laminate plate consists of a rigid part with a layup of $[\pm 45]_6$, and a flexible part with a layup of [0/90], with [90] as the outer ply and the [0] as the contact ply with the rigid adherend. Finally, peel test specimens were cut from the laminate. The geometry is shown in Figure 1. Specimens were 25 mm in width and 250 mm long with a total thickness of 4.3 mm. The mechanical properties of the composite were determined in a previous work³⁰ by conducting tensile tests according to ASTM D 3039 standard.³²
